The Stall Zone

Compressor qualification testing improved

by Robert Shannon, P.E.
Machinery Diagnostic
Services Engineer
Bently Nevada Corporation
Buffalo, New York

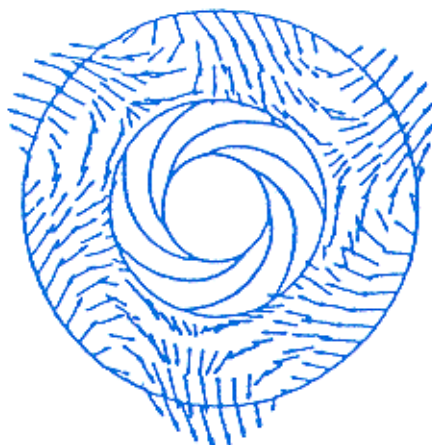
Example of Rotating Stall

- **Surge** - periodic flow oscillations and pressure swings. If these oscillations include flow reversals, it is a deep surge. The rate of gas flow is not enough to adequately fill the spaces between consecutive guide vanes. This might also be called extreme stall. Surge propagates axially.
- **Rotating Stall** - also called "propagating stall." Consists of large stall zones, covering several blade passages, and propagates circumferentially at some fraction of rotor speed. The number of stall zones and the propagating rates vary considerably.
